# Fixed-Type Restoration for a Post-Traumatic Partially Edentulous Anterior Maxillary Area: A Case report

*Management of post-traumatic injury in the anterior maxillary area presents a challenge to surgeons and prosthodontists. This case report presents a 25-year-old female with a severely resorbed partially edentulous anterior maxillary area and previously placed implants. A fixed-type restoration was fabricated for the missing soft and hard tissues. The framework design was divided into crown and gingival portions.*

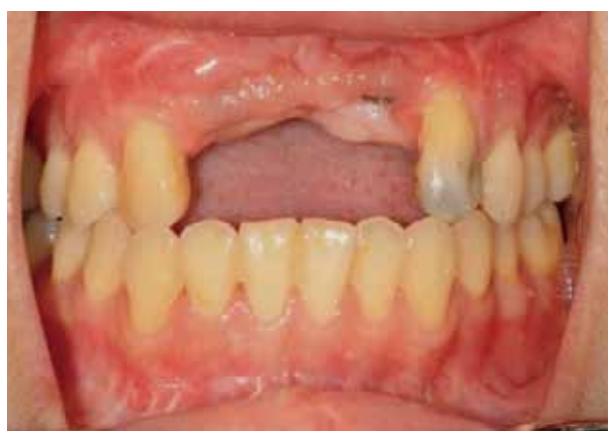
Fig2 Soft tissue loss over edentulous area with cover screw exposure, Crossbite between upper and lower canines and Buccal gingival recession over 23 area are noted

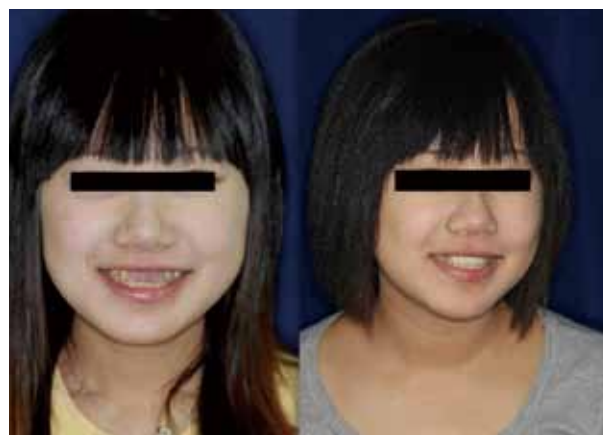
Fig3a Insufficient lip support was noted without wearing prosthesis

Fig3b Soft tissue was improved with temporary fixed restoration

were noted. Extraoral findings and esthetic analysis showed insufficient lip support (Fig3a), blunt naso-labial angle, and no gummy smile. A tentative treatment plan was drawn, which included interim removable dentures to meet urgent esthetic demands and endodontic retreatment for tooth 23. In October, the patient became pregnant and treatment was stopped.

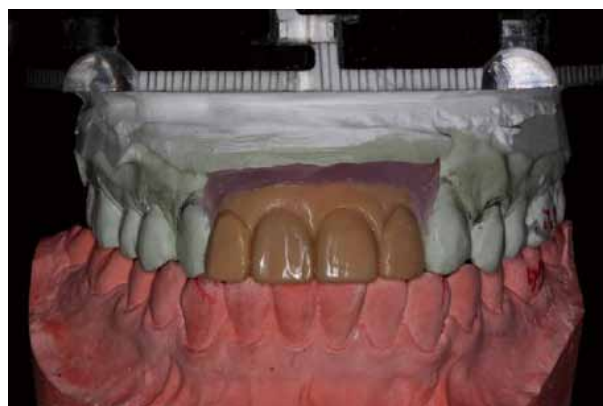
Fig4 Fully wax up

1. Full wax up was conducted (Fig4).
2. The gingival portion was cut back, and crown space was checked.
3. The gingival portion was cast by lost-wax technique (Fig5), and framework fitness was checked with the one-screw test.
4. The crown portion on the gingival portion of the framework was waxed up.
5. The crown portion was cut back, and porcelain space was checked.
6. Crown copings were tried on the gingival portion of the framework, and veneered porcelain was added.

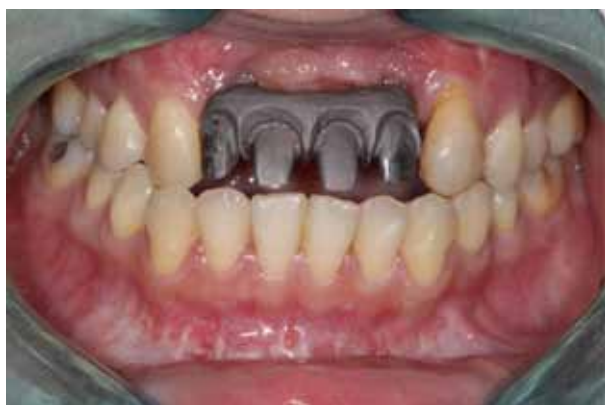
Fig5 Try in of the framework with gingival portion

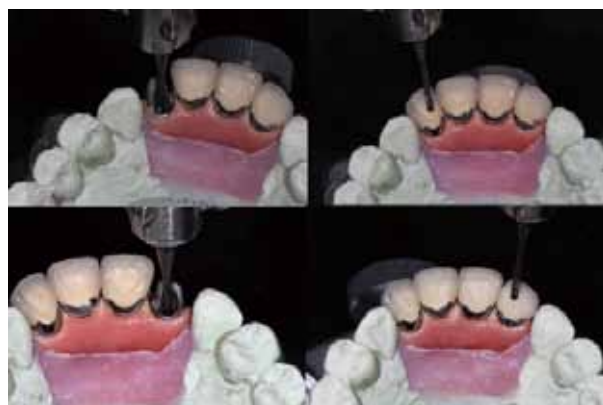
Fig6 Marking access holes on palatal surfaces of the restorations

7. Pink porcelain was added over the gingival portion of the framework.
  8. Staining and glazing was conducted. Access holes were marked on the palatal surface of the crown portion (Fig6).
  9. The prosthesis was delivered (Fig7-8).
- The insertion of the prosthesis involved

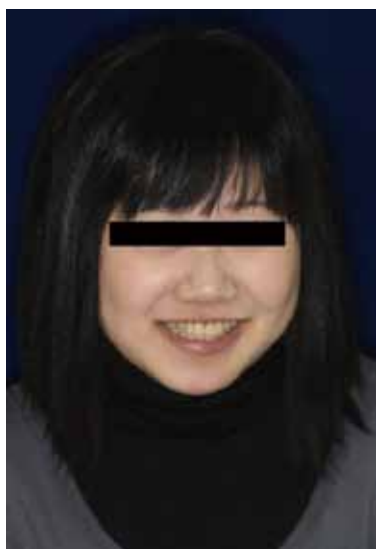
Fig7 Frontal view of the patient after restoration

screwing the framework into place until 25-Ncm torque was achieved and covering the screw-access holes with gutta-purcha and composite resin. The crowns were then placed onto the framework, and the desired occlusal contacts were confirmed. The four crowns were cemented using zinc phosphate cement. Excess cement was removed, and occlusal contacts were once again verified prior to giving the patient postoperative instructions for care and maintenance. The patient was scheduled for recall every three months.

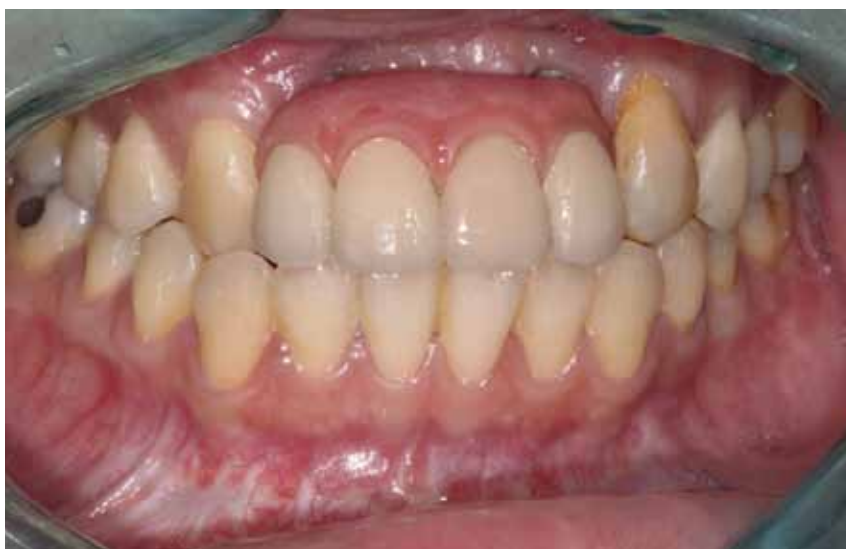
Fig8 Intra oral view with maxillary anterior prosthesis
