## Case Report

# Reversal of the Intrusion of a Natural Tooth between Two Adjacent Implant Restorations: A Clinical Case Report

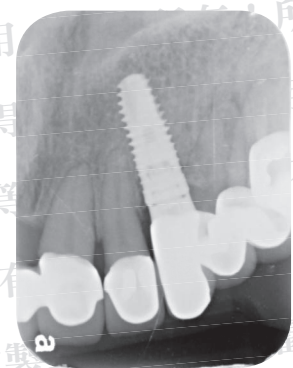
Fig. 2 Periapical radiograph of tooth #23, which was replaced with an implant-supported prosthesis on July 9, 2013.

was uncovered and loaded uneventfully six months later on July 9, 2013, with a cement-retained all-ceramic crown restoration (Fig. 2). At the impression appointment for the dental implant restoration of the tooth #23 area, a fistula with a solitary deep narrow pocket was found over the buccal side of tooth #25, and a root fracture was suspected (Fig. 3). So, tooth #25 was extracted and replaced on November 14, 2013, with a dental implant (Xive®; FRIADENT) 3.8 mm in diameter and 13 mm in length. The dental implant in the tooth #25 area was restored with a cement-retained zirconia crown on June 11, 2014 (Fig. 4).

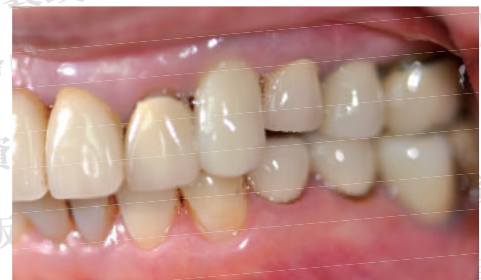
Fig. 5 Tooth #24 was shown to exhibit infra-occlusion in a clinical examination.

During a routine check-up conducted on September 11, 2015, the patient complained that tooth #24 between the two dental implant restorations had become shorter with an unpleasant progressive enlargement of the inter-occlusal gap (Fig. 5). Upon conducting an intra-oral examination, we found infra-occlusion of tooth #24 with a tight proximal

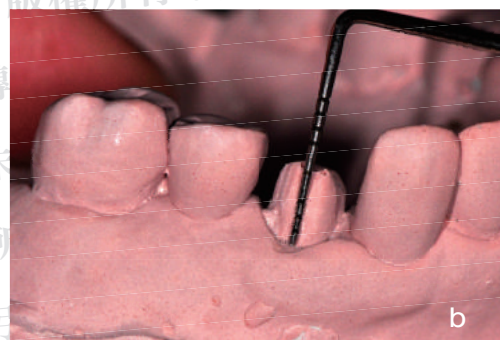
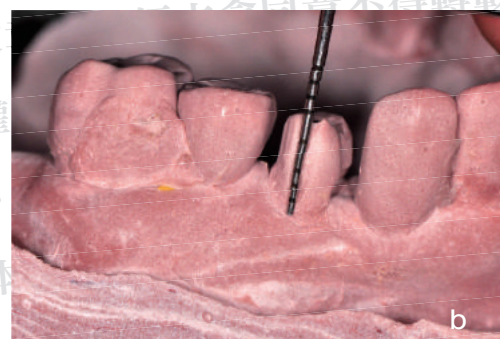
Fig. 9 Stone cast of the relationship between tooth #24 and the tooth #25 dental implant made on September 27, 2016.

performed. In addition to the periodontal care, the adjustment of the provisional crown was performed to remove occlusal and proximal contacts. One year after the delivery of the provisional crown, tooth #24 had been extruded by 2.5 mm (Figs. 8, 9), and the periodontal condition was significantly improved while the percussion pain was substantially relieved. More importantly, the periodontal reevaluation data regarding tooth #24 showed a decrease in the mesial probing depth and the tooth's mobility. In addition to this clinical improvement, periapical radiography revealed that the root apex of tooth #24 was at the level of the 6.5 screw thread from the apex of the tooth #25 dental implant, with a significant reduction of the mesial angular bony defect and improvement of the trabecular projection (Fig. 10).
