## Case Report

# An Alternative Approach for Removing a Fractured Implant Abutment Screw: A Case Report

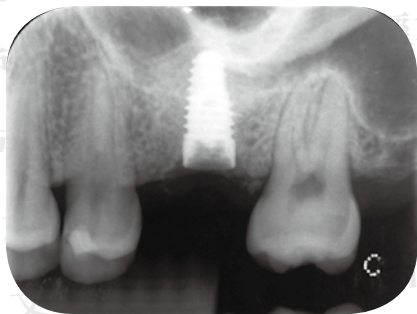
Fig. 1. Radiograph of the fractured abutment screw after crown removal. It demonstrated that the failed abutment screw remained within the implant body.

A 30-year-old male patient presented to our dental clinic with a loosened crown on the maxillary left first molar; the crown had been retained with an abutment screw over an implant (PrimaConnex® implant: Ø5.0 × 10 mm length; Keystone Dental, MA, USA) for 3 years. A dental radiograph indicated that the abutment screw of the maxillary left first molar had fractured at the junction of the screw shank and screw thread. The abutment screw fragment was 2 mm below the platform of the implant fixture (Fig. 1).

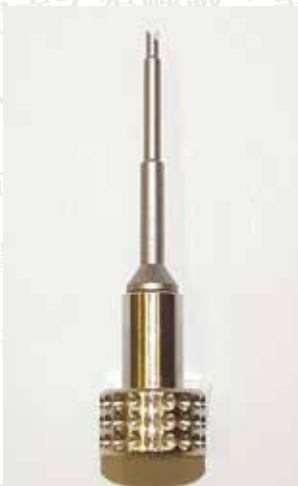
Fig. 2. Screw removal instrument (Lucky, SC-1713, ADL Bio, Seoul, Korea). The sharp-edged tips of the screw removal instrument can engage the irregular top surfaces of fractured screw fragments.

1. A screw removal instrument (Lucky, SC-1713, ADL Bio, Seoul, South Korea) was selected to remove the fractured fragment (Fig. 2). The sharp-edged tips of this instrument were designed to easily engage the irregular top surface of the fractured screw fragment, which helped the user to unscrew it.

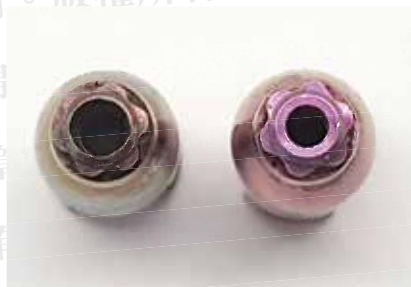
Fig. 3. To accommodate the slightly wider shank of the screw removal instrument, the channel of the implant impression post was enlarged. The impression post on the left is the enlarged one. The impression post on the right is the original one.

2. A corresponding "impression post" ( $\varnothing 5.0$  mm), a component for implant-level impression to transfer the index position, angle, and depth of the implant, was employed. This component can serve as a specific guide to access the screw hole in the implant bore because the outer feature precisely fits the internal feature of the implant to make the component stable, while the inner channel provides a means of access by which to locate the fractured fragment in the screw hole. Unfortunately, the diameter of the shank of the screw removal instrument was slightly larger than that of the channel of the impression post. Therefore, a customized guide cylinder was modified from the original impression post by enlarging its diameter with a C-S2 tungsten carbide bur (Diaswiss SA, Nyon, Switzerland) in an electric straight handpiece (Fig. 3, Fig. 4, Fig. 5).

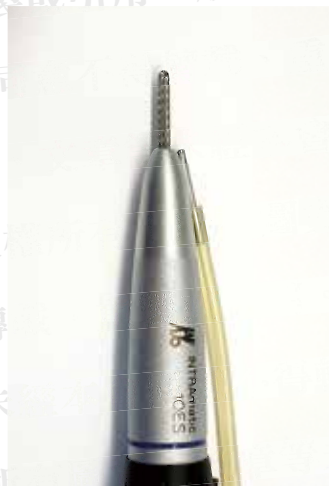
Fig. 4. A C-S2 tungsten carbide bur (Diaswiss SA, Nyon, Switzerland) in an electric straight handpiece was used to enlarge the impression post.

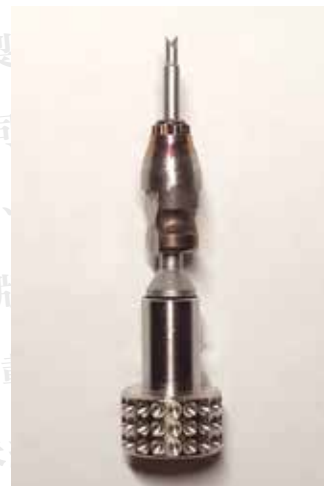
Fig. 5. The screw removal instrument could pass through the enlarged impression post.

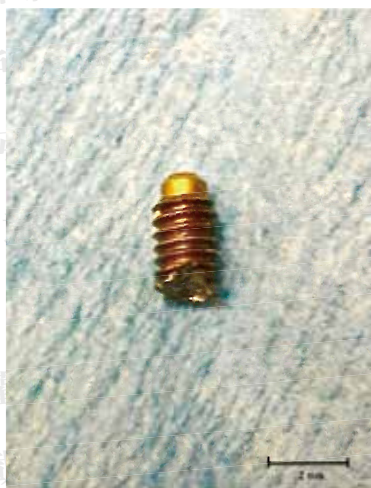
Fig. 6. Retrieved abutment screw fragment.

without slippage. A light vertical force was applied parallel to the long axis of the implant so that the screw removal instrument could engage the fractured abutment screw with the sharp-tip end. Then, the screw removal instrument was manually rotated in a counterclockwise direction. Finally, the fractured fragment was retrieved efficiently without damaging the internal threads of the implant fixture (Fig. 6, Fig. 7).

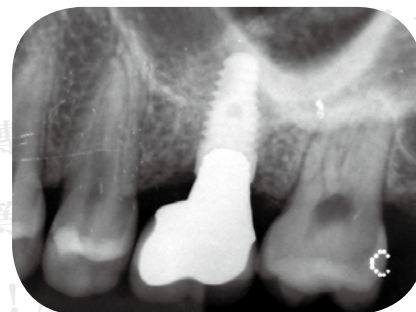
Fig. 8. Radiograph of the new implant-supported prosthesis.

4. A new abutment and screw were employed to fabricate a new implant-supported prosthesis (Fig. 8).
